DEVELOPMENT OF MANUFACTURING METHODS  
FOR IMPROVED DELAY LINES

Authors: Russell T. Mannette, Frank M. Hendry, Beverly A. Shaw  
Raytheon Company, Microwave and Power Tube Division  
Waltham, Massachusetts

Technical Report AFML-TR-67-281  
October 1967

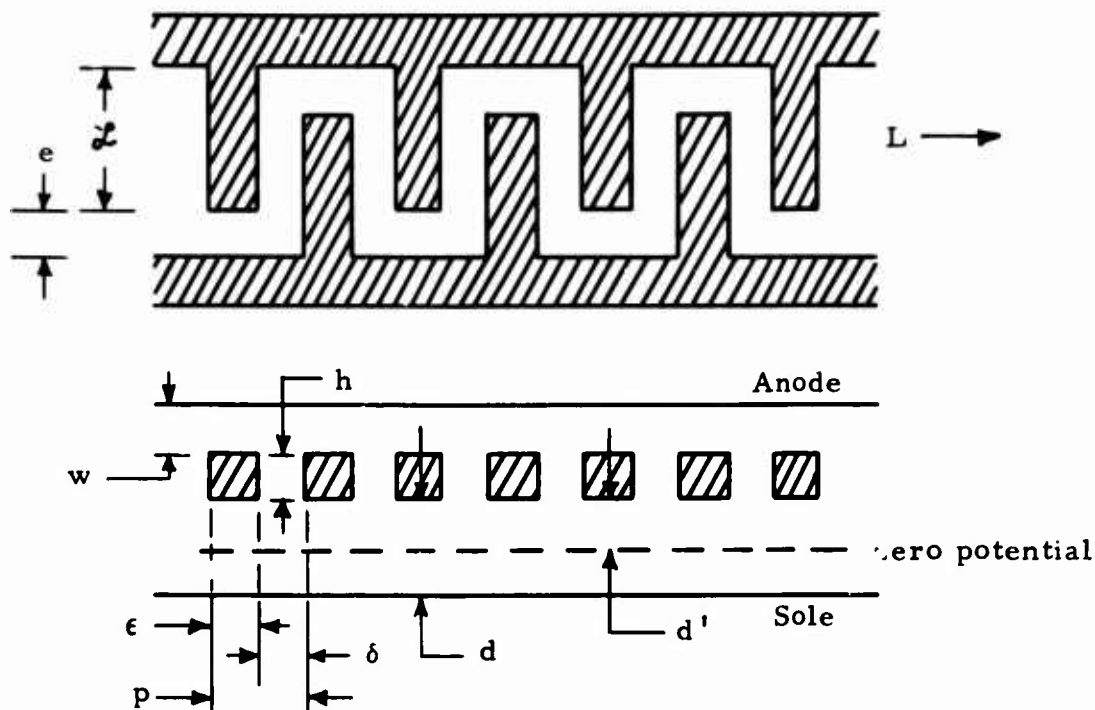
### Delay Line Nomenclature

- $e$  = end spacing
- $\mathcal{L}$  = finger length
- $L$  = length of line
- $h$  = finger height
- $w$  = backwall spacing
- $\epsilon$  = finger thickness
- $p$  = pitch
- $\delta$  = finger spacing
- $d$  = sole to anode spacing
- $d'$  = anode to zero potential line
- $N$  = number of pitches

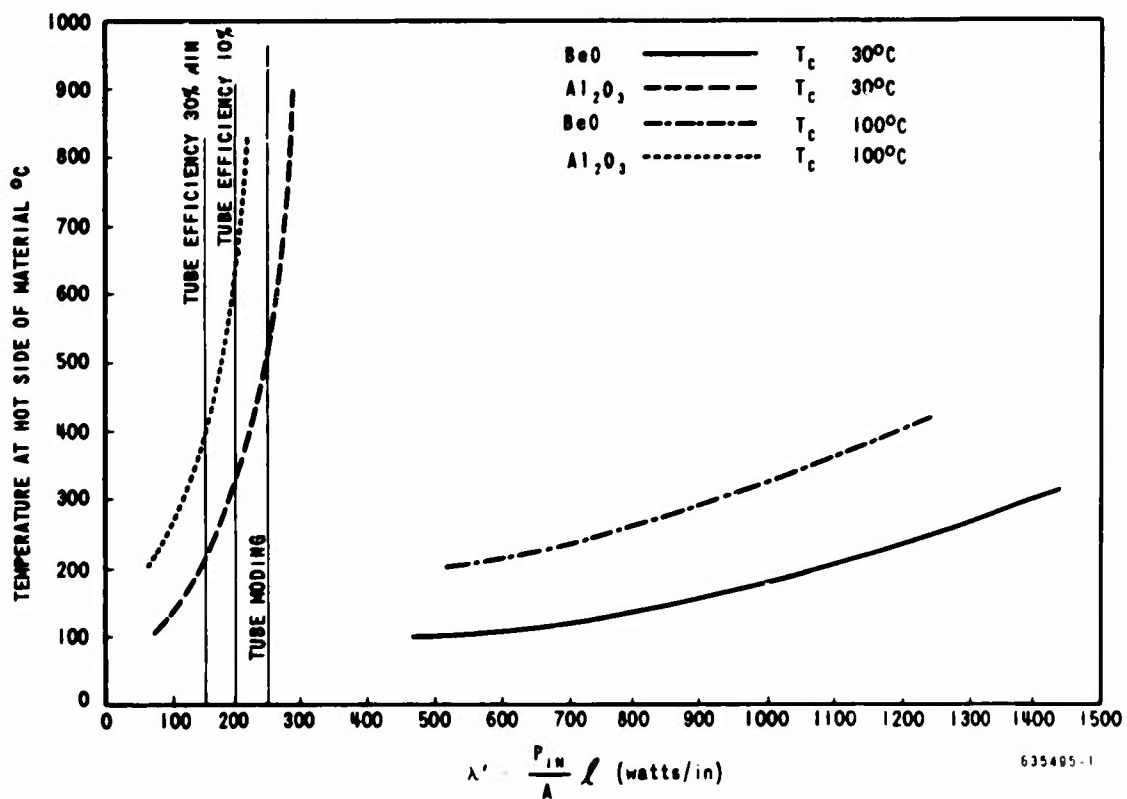
Figure 2. Temperature vs  $\lambda'$

Large signal theory has consistently shown that, assuming normal operation with good beam focusing, the most concentrated beam collection will occur for the most efficient interaction over an area corresponding to 10 interdigital delay line fingers for 50% of the beam. The surface temperature of the SWS was then calculated for three separate conditions using the curves in Figure 2 which were derived from ceramic manufacturers' data. The curves show the hot side temperature ( $T_H$ ) based on cold side temperatures of  $30^\circ\text{C}$  and  $100^\circ\text{C}$ , vs a parameter  $\lambda'$  which is defined as

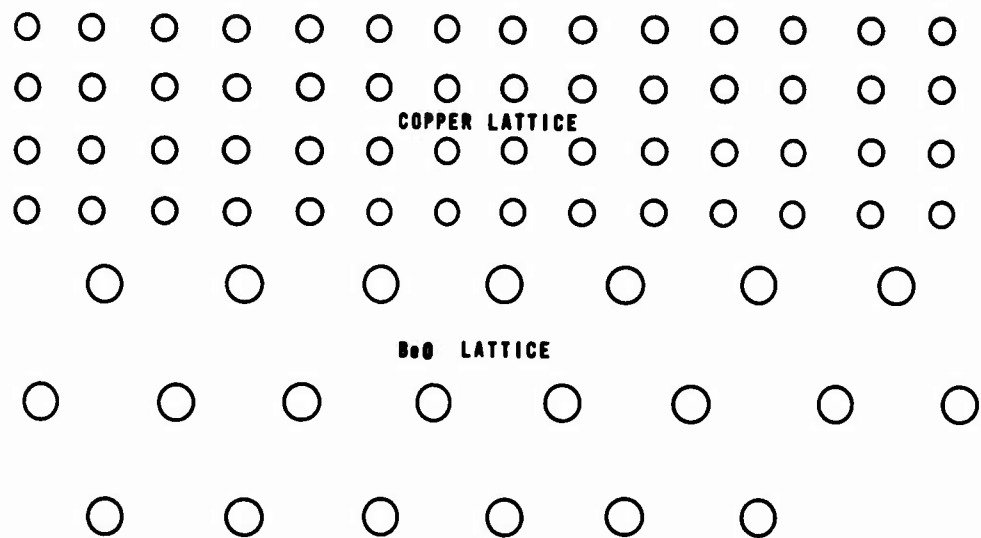
a. No Graded Bonding Structure

Figure 3a shows the effect of simply evaporating copper onto a beryllia substrate and represents the mismatch evident under these conditions.

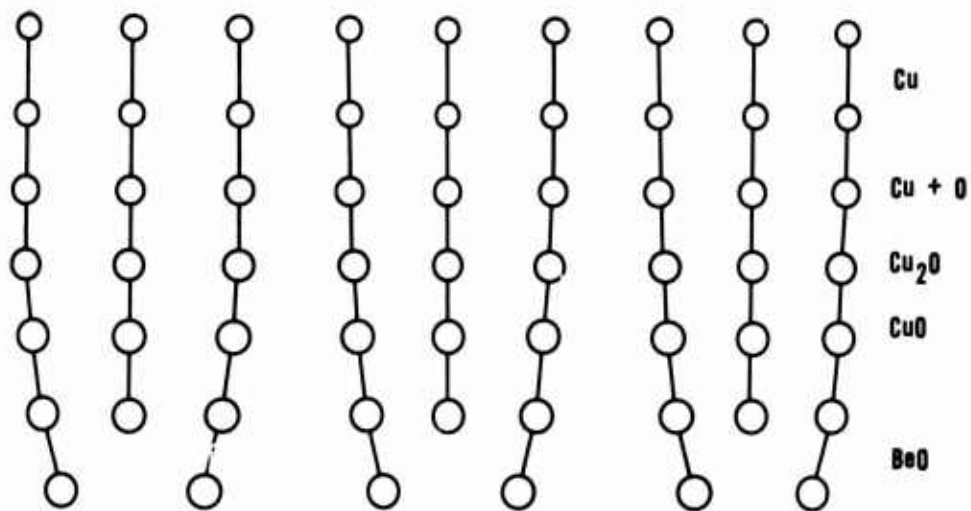
b. Bonding Structure of Graded Copper Oxides

In Figure 3b the grading effect of the intermediate layer is shown diagrammatically. The conditions of preparation of the film are adjusted so that the material at the ceramic surface is an oxide of a metal similar in lattice parameter and chemical characteristics to the base ceramic. The film material at the outermost surface of the metal layer has a lattice parameter and chemical characteristics similar to the metal layer. The intermediate material provides the transition between the oxide and the metal.

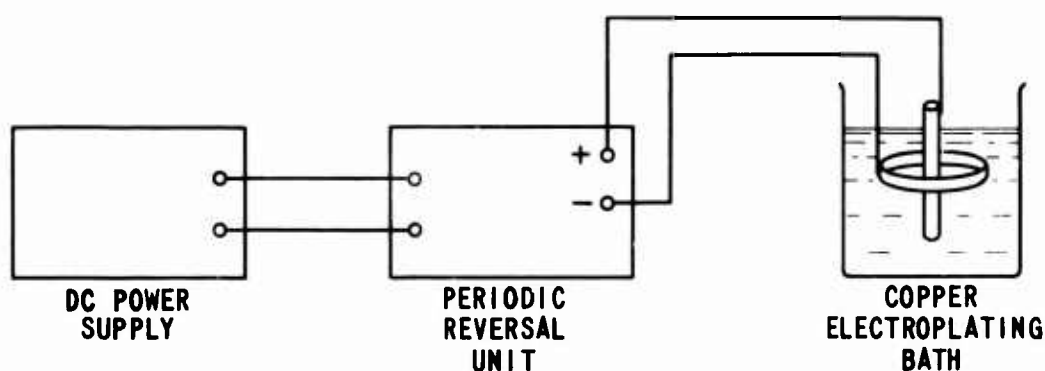
Figure 5. Copper Plating Set-Up

The ring is suspended in the electrolyte in a horizontal position and a 1/4-inch diameter OFHC copper rod is held so that it runs through the center of the ring. This becomes the anode and the ring itself becomes the cathode. Cathode and anode are connected to a periodic polarity reversal unit which, in turn, is fed from a dc power supply. The reversal unit is arranged to forward plate for 1 minute and reverse plate for 15 seconds in a periodic repetitive sequence. This method gives a smoother plate than would otherwise be obtained. The plating conditions are as follows:

In practice, the piece is plated in the forward direction for 7 minutes before turning on the periodic reversal unit. This is necessary to provide a sufficient base for the subsequent plate. Figure 5 shows a diagram of the plating process.

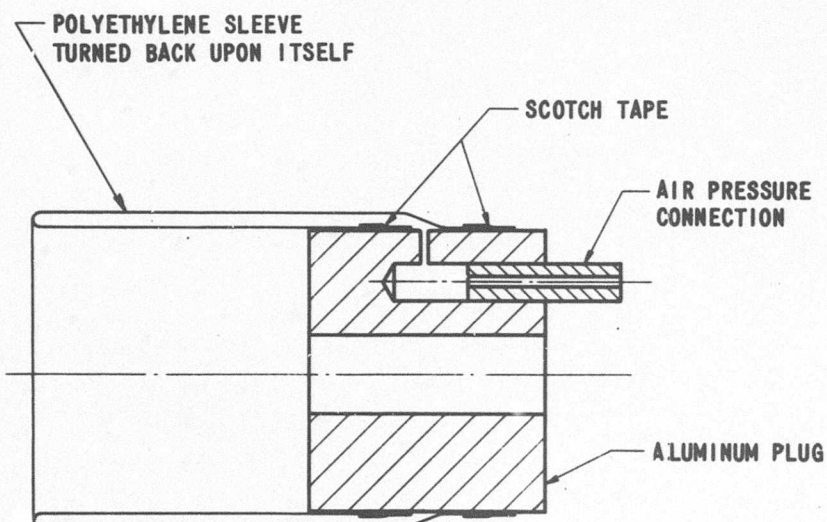
Figure 7. Exposure Device, Diagram

This device, shown in the sketch of Figure 7, and in the photographs of Figures 8 and 9, consists of a polyethylene sleeve turned back upon itself and secured to the outside of an aluminum plug having a central longitudinal hole and a suitable air channel. An important aspect of the design of this device is that the diameter of the sleeve is made slightly smaller than the inside diameter of the cylinder. Thus the cylinder may be readily slipped over the sleeve without bringing any strain on the transparency, which is accurately positioned against the photoresist-coated surface of the cylinder. The sleeve can now be inflated, bringing a wrinkle-free uniform pressure against the transparency and forcing it tightly against the cylinder. A hole through the block that supports the polyethylene sleeve permits a miniature tubular ultraviolet fluorescent lamp to be passed through, with electrical connections to the lamp being made in conventional fashion.

A solution was found in a pneumatic pressure device consisting of ring-shaped transparent balloon, through the center of which the exposing light could be passed, and which would force the photomask against the cylinder surface with a uniform pressure. This device and its use is now described in detail.

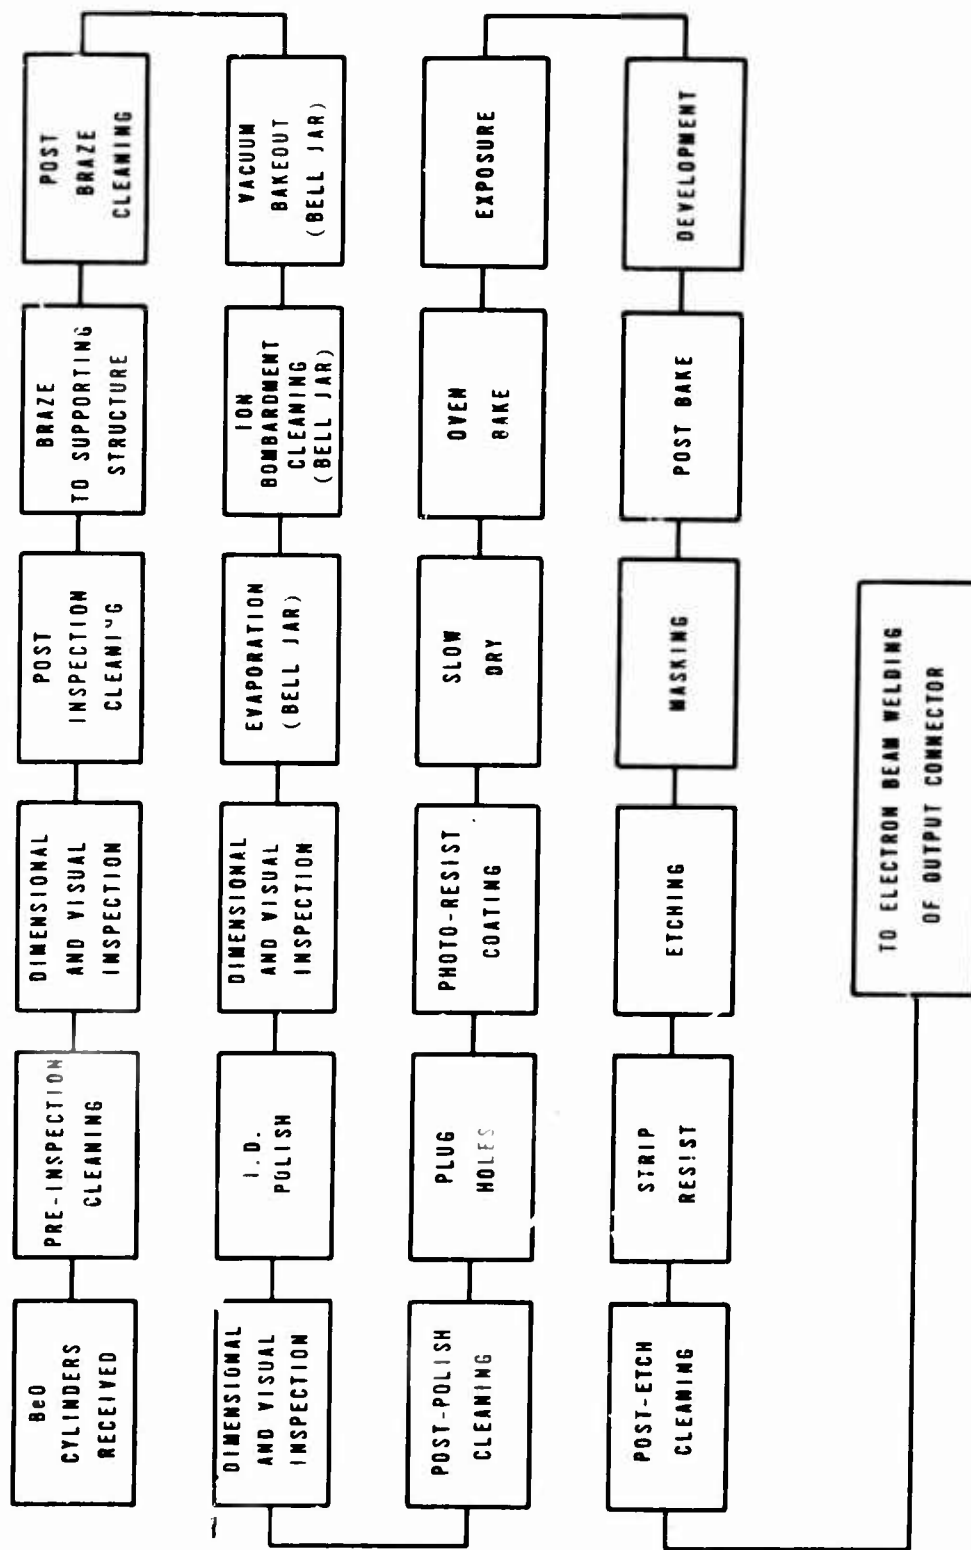
Figure 10. Fabrication of QK1329 Cylinder Slow-Wave Structure

Starting Point: - BeO cylinder brazed into the copper supporting structure and entire assembly chemically clean and dry.

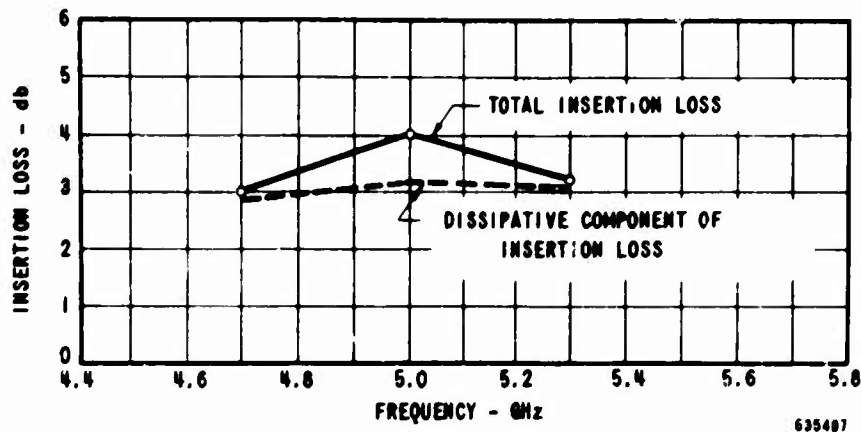
Figure 16. Insertion Loss Measurements Taken on QK1329 Delay Line Photocopies on Stycast No. 6

Figure 16 shows the results of the measurements taken on a full-length line photodeposited on Stycast 6. The values obtained are approximately of the same magnitude as those obtained in the conventional X-band tubes. Conventional C-band tubes have a value in the order of 1.5 to 2.5 db. This means that although the present level of insertion loss is higher than the conventional tube, it is not high enough to seriously affect tube operation.

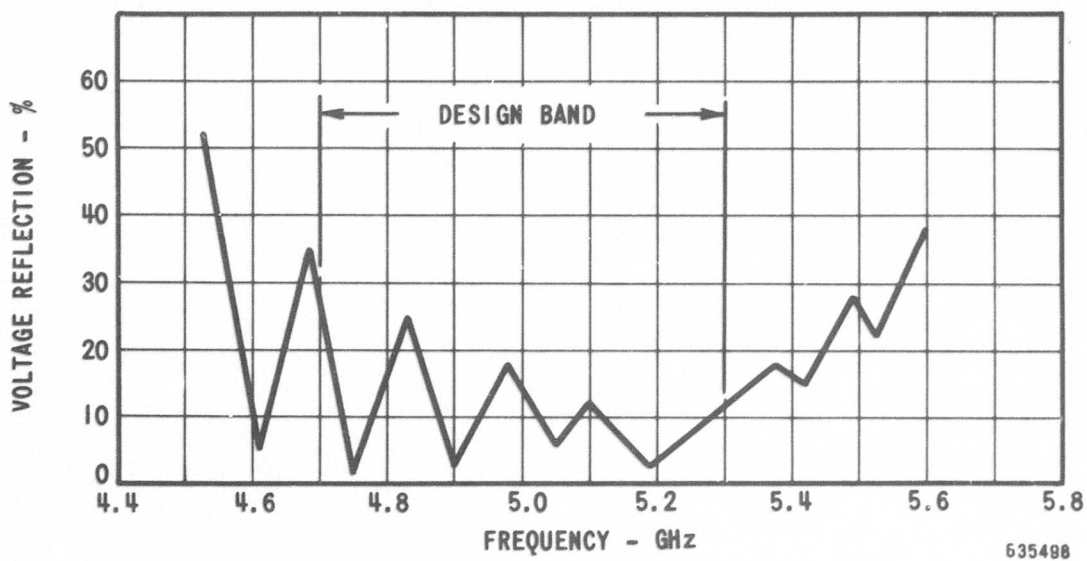
Figure 18. Cold Test Match Linear C-Band Slow-Wave Structure on Stycast Substrate Line Terminated in 50 ohms Coaxial Matched Load

The initial cold test work was done on a substrate of Stycast 6, rather than beryllia, since it could be machined by conventional techniques. Once the initial configuration of the substrate was determined, linear beryllia strips were ordered from a vendor. This cold test model is shown in Figure 17 while Figure 18 shows the percentage voltage reflection vs frequency.

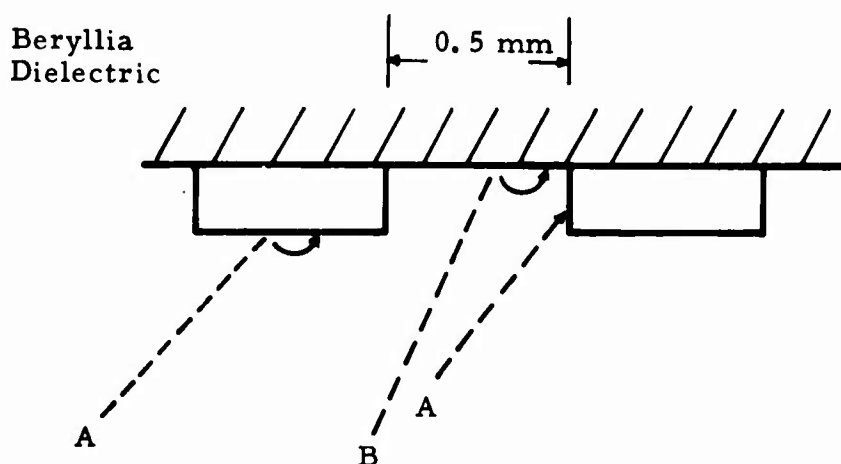
Figure 23. Delay Line Surface

Figure 23 is a sketch of the geometry at the surface of the delay line.

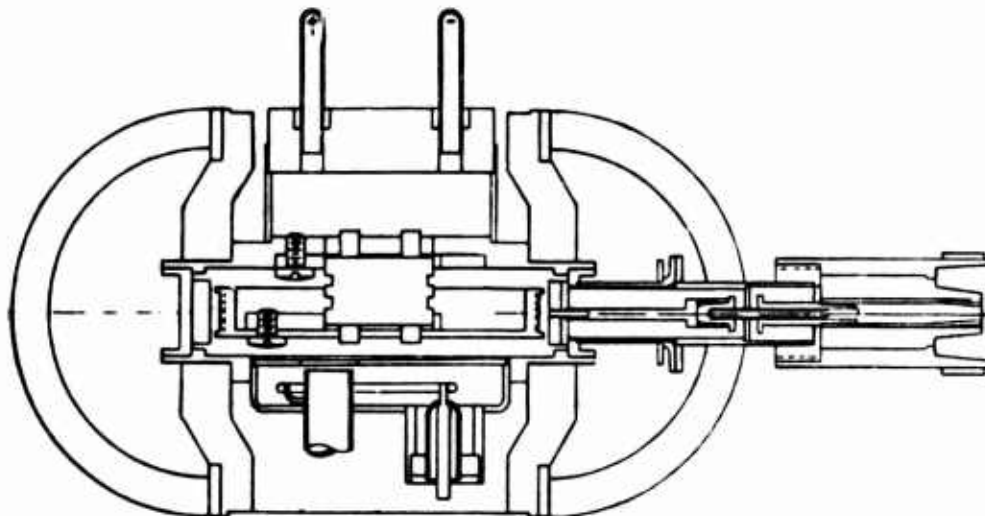
Figure 24. Cross Section of Test Vehicle for Evaluation of Slow-Wave Structure (C-Band M-Type BWO)

A cross section of the test vehicle is shown in Figure 24.

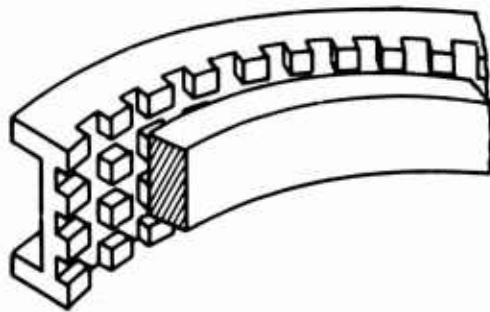
The tangential stresses were reduced by machining orthogonal slots in the copper cylinder in the area of the braze as shown in Figure 25. This "waffle plate" effect allows the copper to yield under the stresses due to differential expansion, thus reducing stresses in the ceramic. Since this method was initiated, there have been no instances of cracked ceramics.

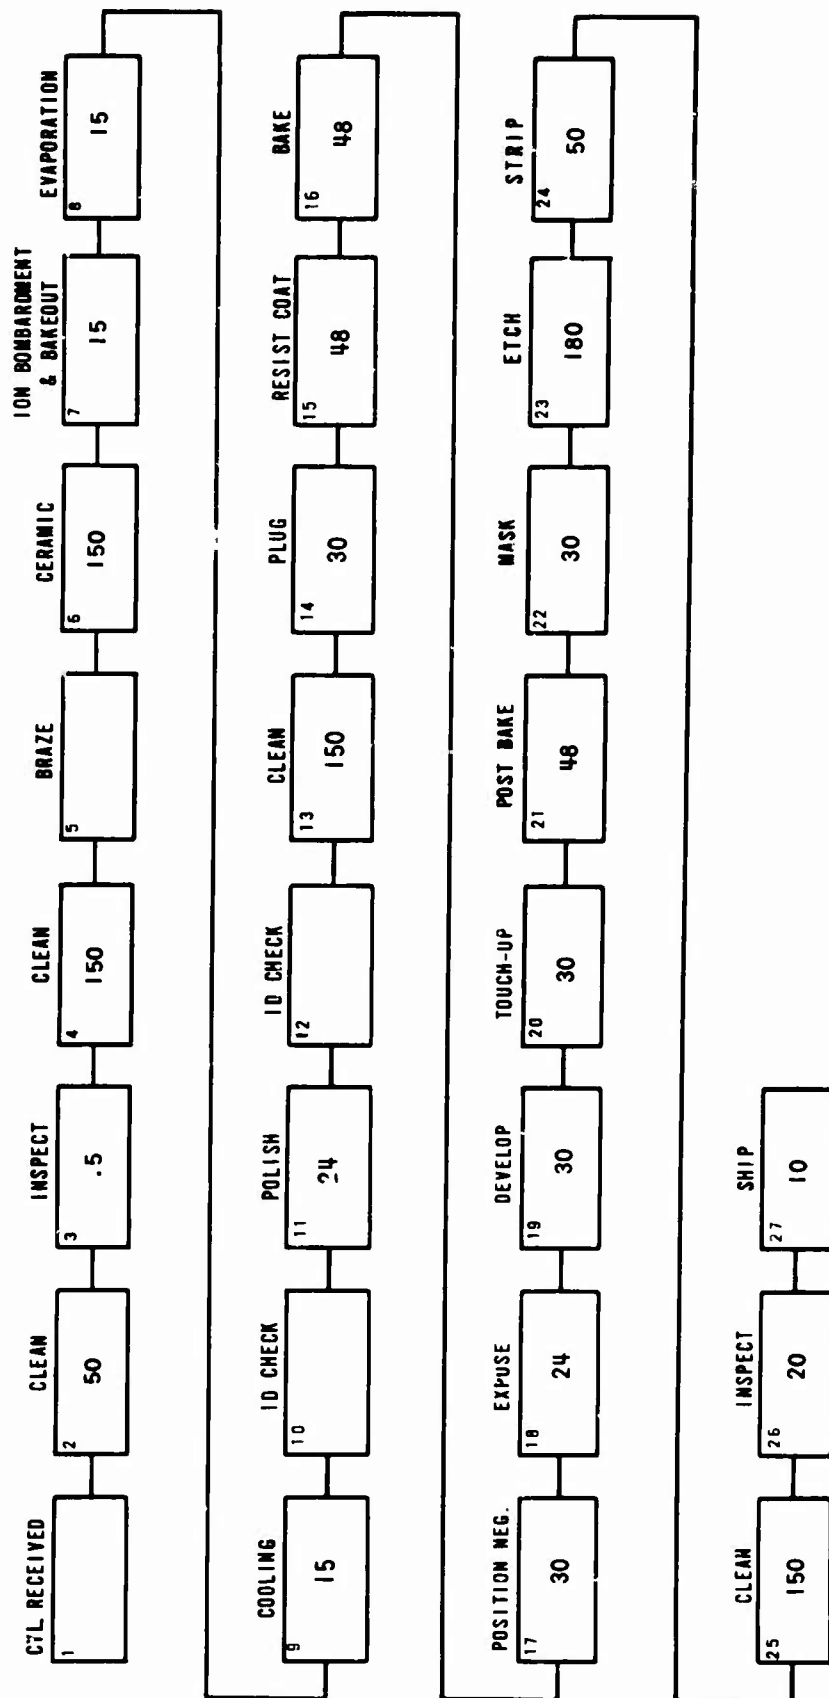
The block diagram of Figure 28 gives the anticipated rates of production for each step in the process.

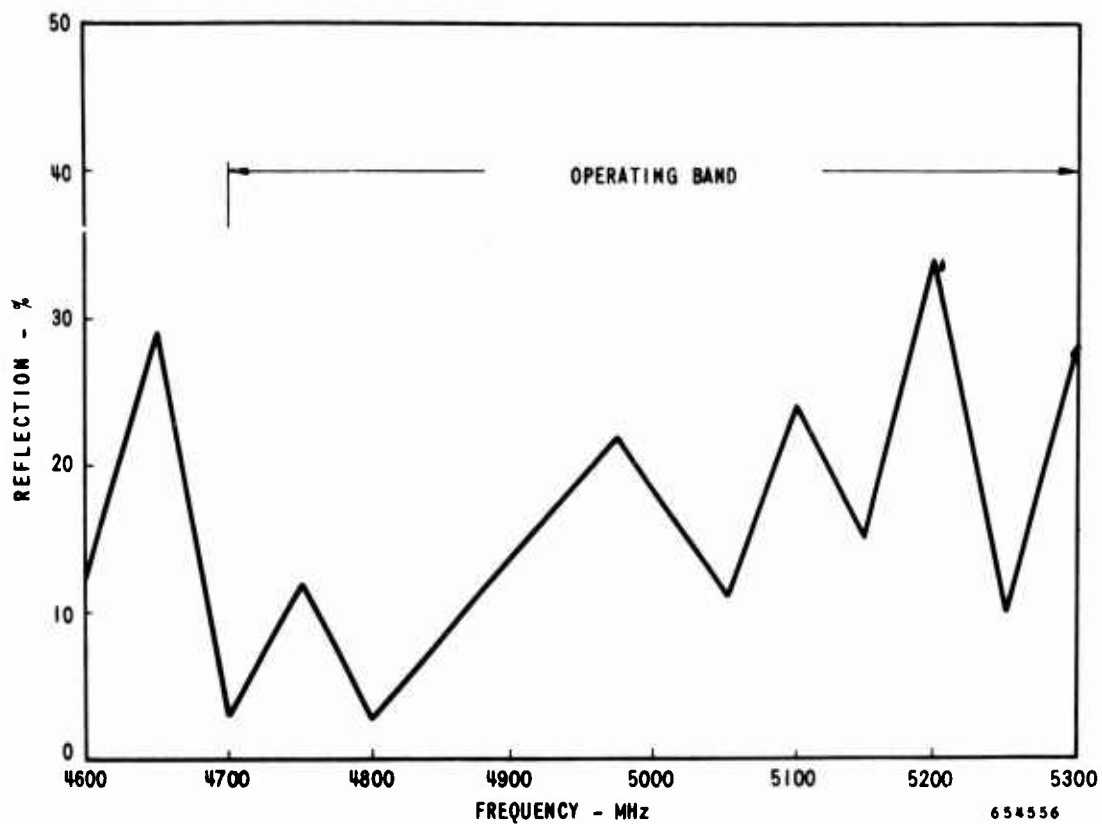
Figure 46. QKA1329 Test Vehicle No. A-1  
VSWR

After approximately 24 hours of operation, the tube failed because of apparent excess arcing between the sole and anode. Analysis revealed that the first portion of the line had been destroyed over a distance of 10 to 15 pitches. At the time it was felt that local overheating of the delay line had caused the bond to fail, or that possibly the failure was due to the leak in the tube during bakeout, which is done in a reducing atmosphere and which had allowed the forming gas to reduce the oxide in the bond. The actual cause of failure was later determined to be the etchant attacking the  $\text{CuO}_x$  bond region. A further discussion of this is given in Section 2.2.5.7.

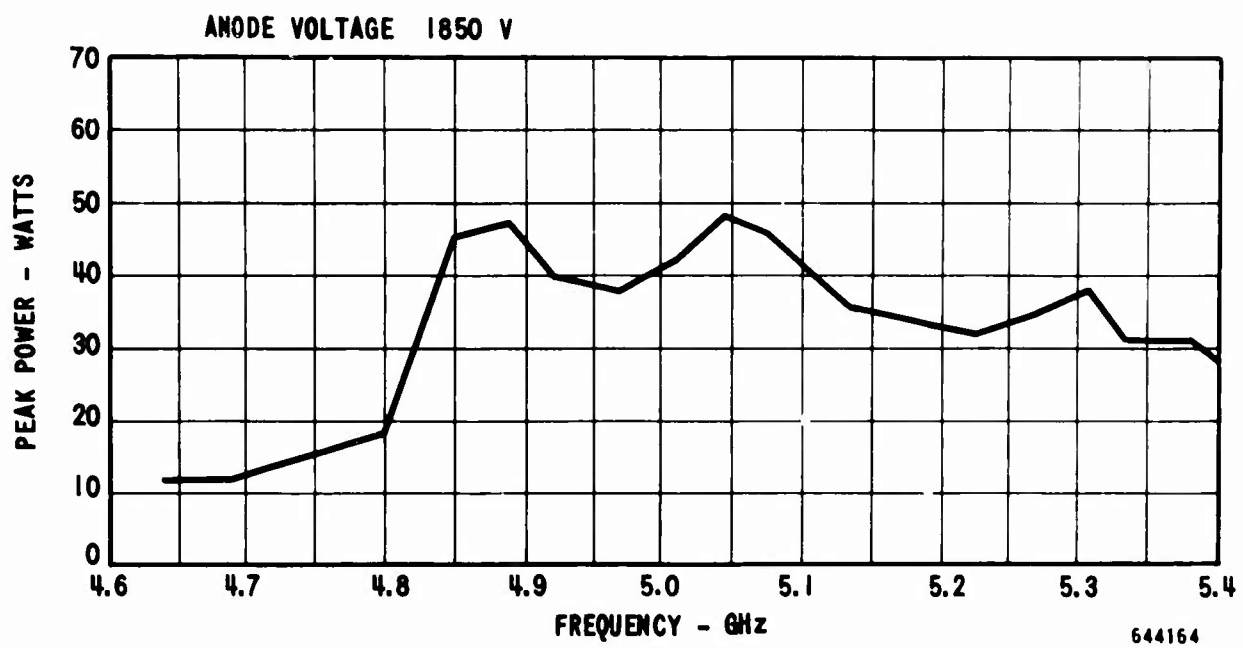
Figure 50. QK1329 Test Vehicle A-3 Power vs Frequency  
Pulsed Operation 10% Duty Cycle

There was no evidence of accelerator current at peak currents up to 300 mA, so the gun modification appears to be satisfactory. The tube was prone to arcing, however, and had to be aged occasionally during operation. A performance curve taken under these conditions is shown in Figure 50.

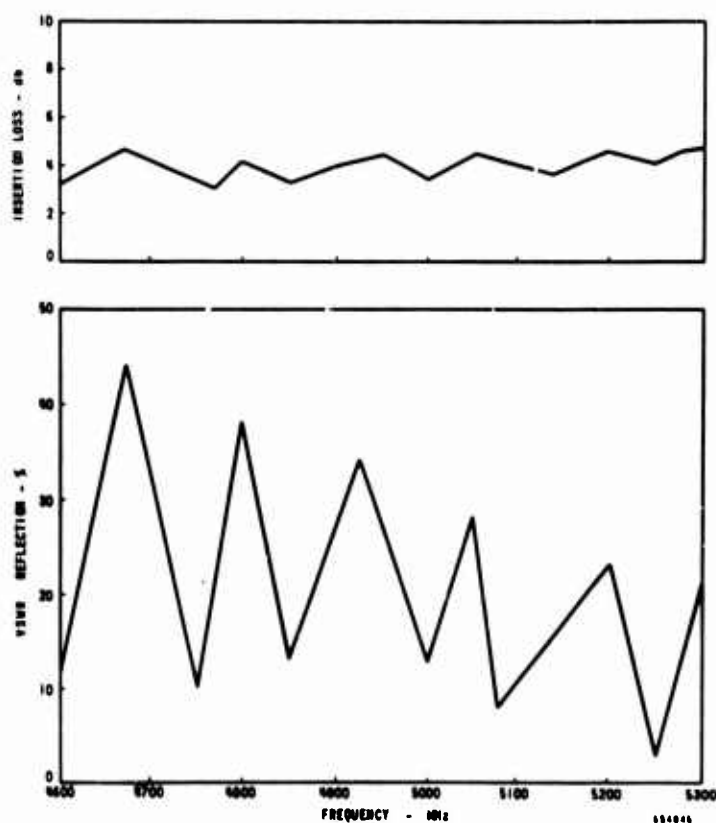
Figure 64. QKA1329 Test Vehicle No. A-8 Circular C-Band SWS  
Serial No. C-150R Insertion Loss and VSWR

This tube, constructed in a similar manner to QKA1329 No. A-6, developed a leak during the initial process. The leak was repaired and evaluation was started by pulsing the tube at a 25% duty cycle. Initial performance was satisfactory but the power soon deteriorated. An insertion loss was taken and found to be 20 db. The tube was scrap-analyzed. A black deposit was observed on the delay line. Both spectrographic analysis and chemical analysis failed to positively identify this deposit. Traces of iron came from the etching process which includes ferric chloride. Another anode assembly was tested in which the anode was washed in distilled water. The water was tested by titration with silver nitrate for chloride residual which was indeed present. The cleansing process was revised to more thoroughly remove these chlorides. As this is the first time that this has occurred, this particular anode assembly may not have been properly cleaned. Figure 64 shows VSWR and insertion loss for this tube.

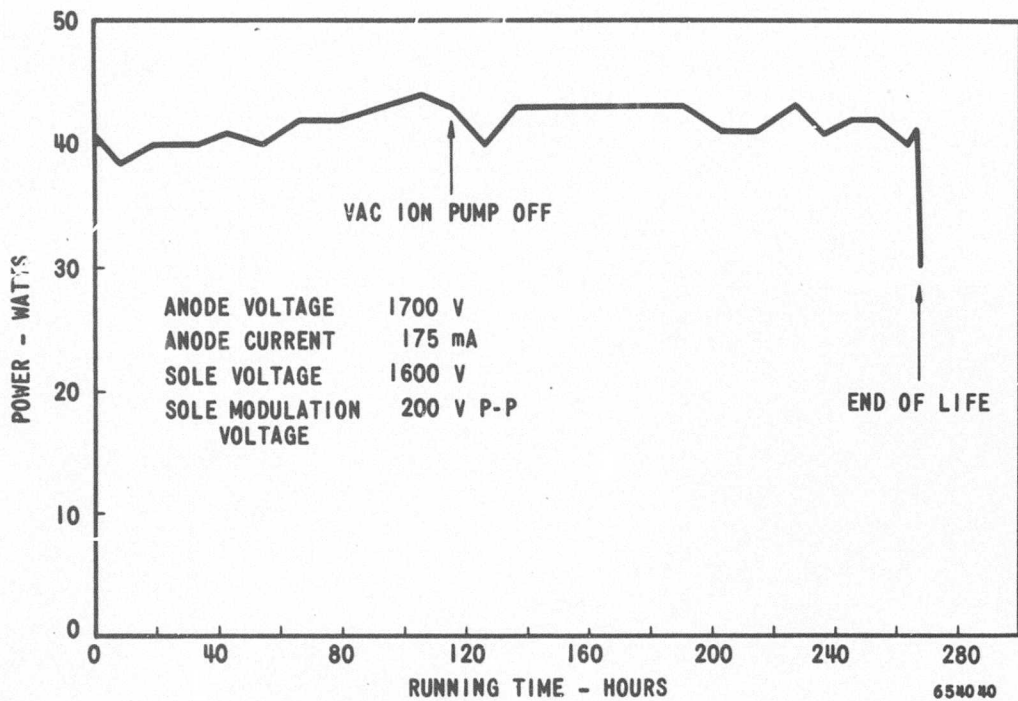
Figure 65. QKA1329 Test Vehicle No. A-6  
Power Variation with Life

It has not been possible, because of the many unknowns involved, to obtain an explanation of the exact mechanism of failure of this tube.

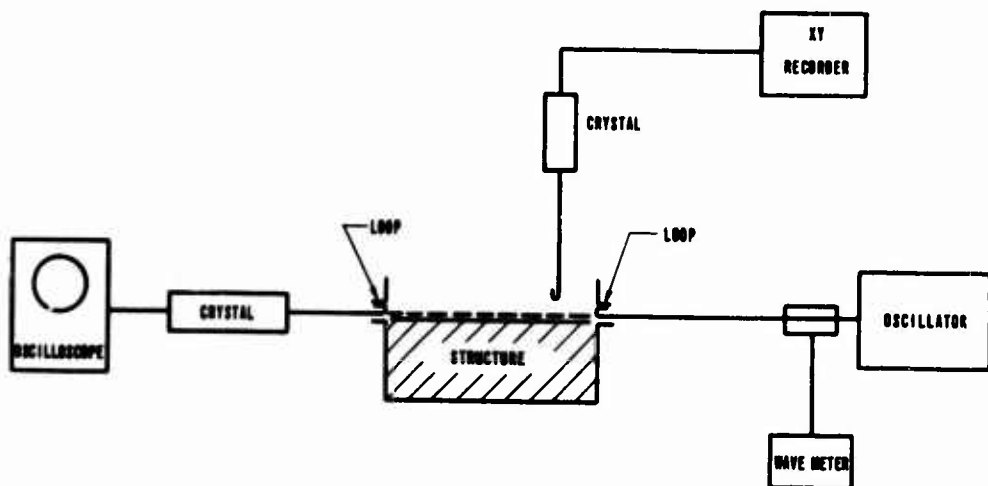
The test setup for measuring the quantities in Eq. (D. 6) is shown in Figure D-1. The signal from the oscillator is varied until a resonance is detected on the oscilloscope. Its frequency is noted and the resonance number then found by probing the field pattern near the structure and identifying the number by counting the peaks in the pattern. The values obtained are substituted in equation (D. 6) to find the  $(c/v_0)$  vs  $\lambda$  relationship.

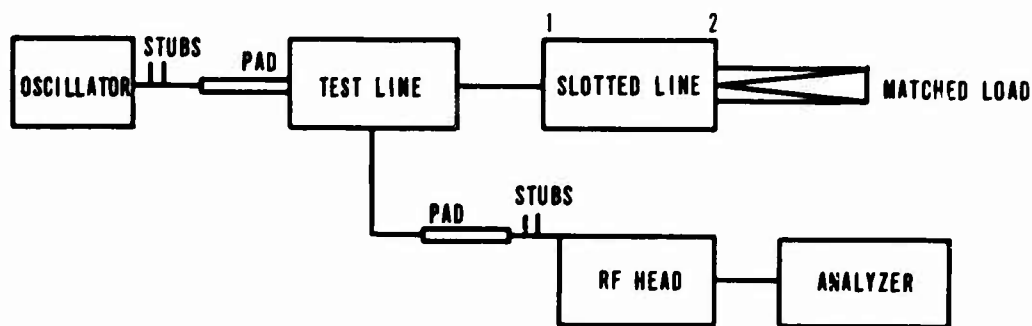
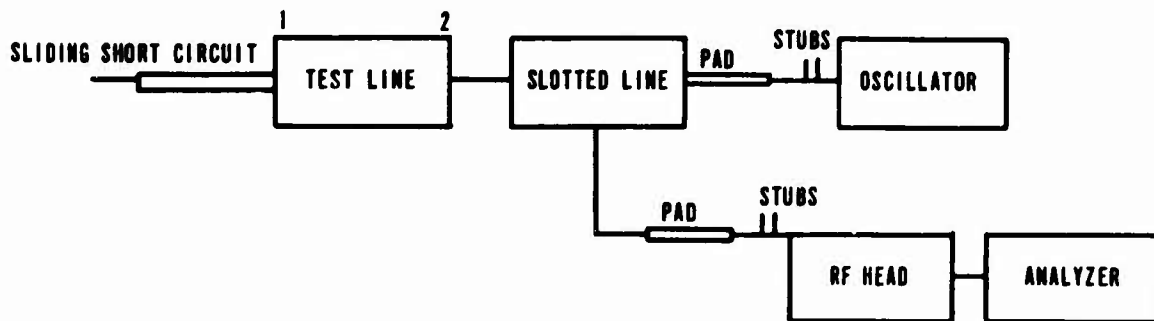
The test setup for measurement of the required values is shown in Figure F-1. In the measurement of  $A_D$ , it should be noted that the device is reversed from its normal orientation as noted in the diagram.
